# Manhole Inspection Summary

Manhole # S35Q\_\_071MH

Insp Date: **2/12/08 10:51 AM**

**Location** Address: **1122 s.charles st**

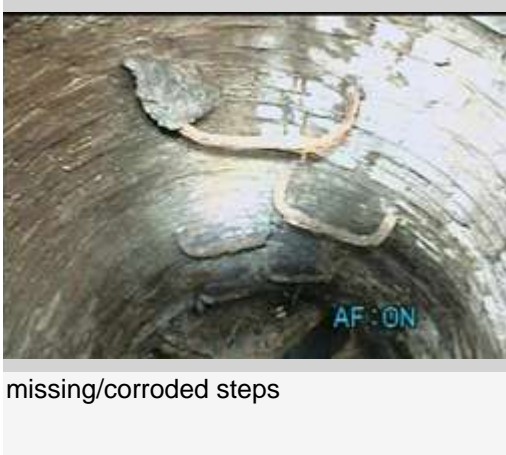
Defect 1

Count: **6** Missing: **1** ☒ **Corroded**

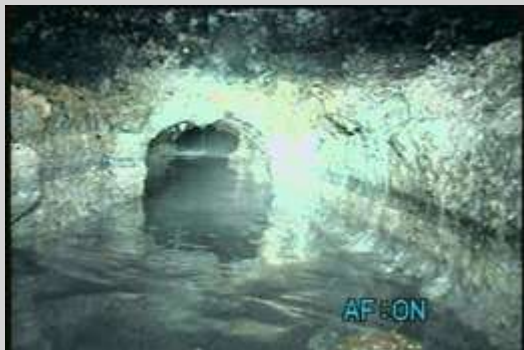
12 O'Clock Outflow

10 in. Circular Gravity Sewer  
Pipe Out @ 12 O'Clock

Deposits: ☐ None ☐ Mud ☐ Sludge ☐ Debris ☒ **Grease**

Silt Depth: **2** (in.) Deposits Extent: **Medium**

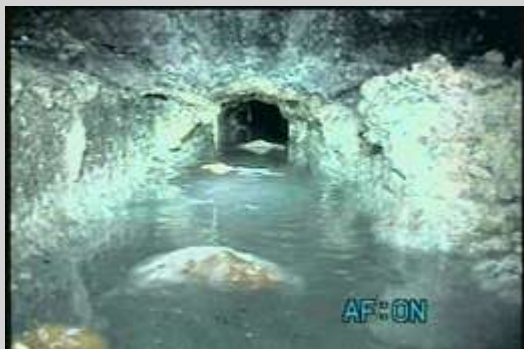
6 O'Clock Inflow

10 in. Circular Gravity Sewer  
Pipe In @ 6 O'Clock

Deposits: ☐ None ☐ Mud ☐ Sludge ☐ Debris ☒ **Grease**

Silt Depth: **3** (in.) Deposits Extent: **Medium**

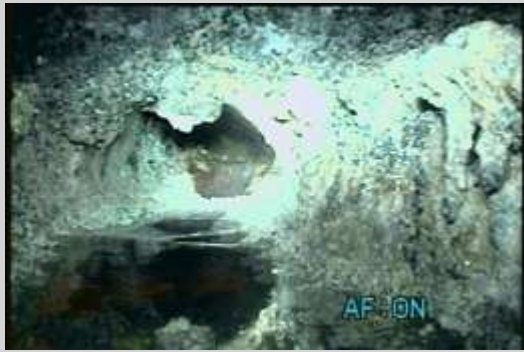
8 O'Clock Inflow

8 in. Circular Gravity Sewer  
Pipe In @ 8 O'Clock

Deposits: ☐ None ☐ Mud ☐ Sludge ☐ Debris ☒ **Grease**

Silt Depth: **4** (in.) Deposits Extent: **Heavy**
